TECHNICAL REPORT NO. 1-813

**THE STABILITY DURING CONSTRUCTION
OF THREE LARGE UNDERGROUND
OPENINGS IN ROCK**

E. J. Cording

January 1968

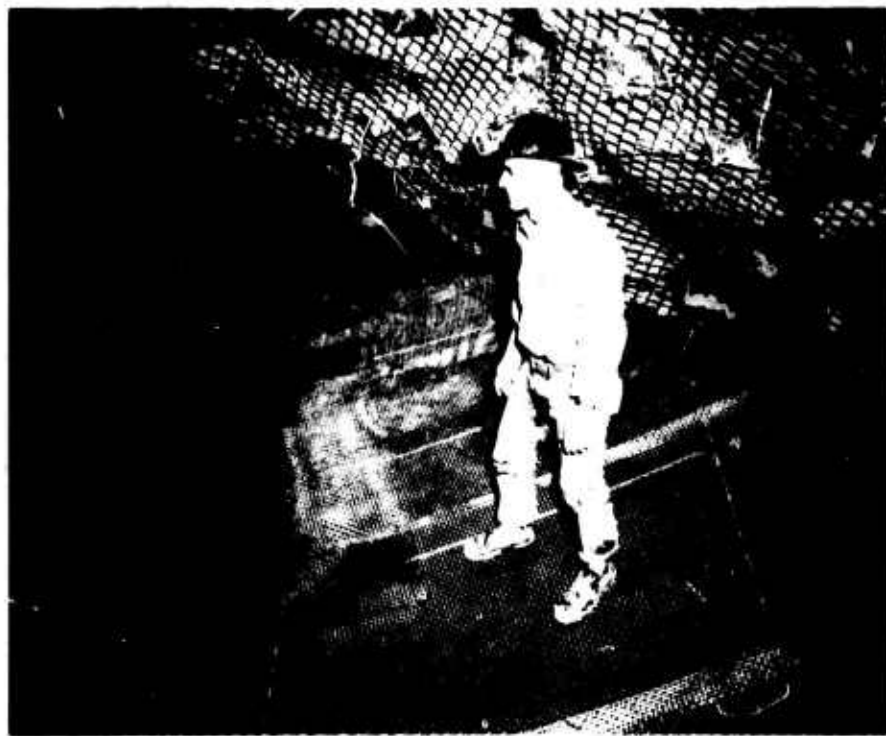
Fig. 9. Safety net below dome of Cavity I

Wire safety nets (1/2-inch mesh) were placed across Cavities I and II, 30 feet below the dome, after construction had proceeded approximately 20 feet below that elevation. The net prevented rock and broken bolts from falling on the men working below. It also proved to be a useful means of gaining access to the dome of the cavity (refer to Fig. 9). From the net, the condition of the rock surface could be checked, extensometers read, bolts replaced, and gunite placed.

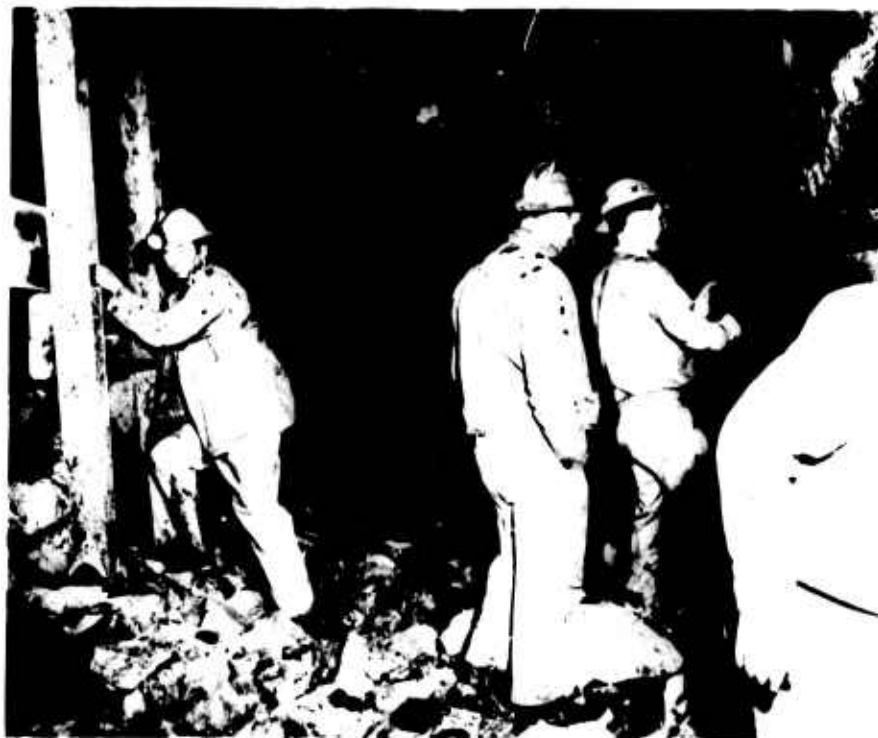
a. View along drift center line

b. 12 ft above floor of drift in raise

Fig. 17. Good to excellent rock, station 2+00 (raise station),
Cavity III access drift

The Rock Mass Quality in the last 100 feet of the main drift was good to excellent; there were no critically oriented faults; and the only support required was a few 6-foot rock bolts to hold loose slabs. The major high angle joint set was present in this portion of the drift as a series of tight joints spaced on 1- to 3-foot centers (Fig. 17a). Fig. 17b shows the rock being barred down, 12 feet above the main drift at station 2+00, after blasting the first round for the raise. This is excellent rock.

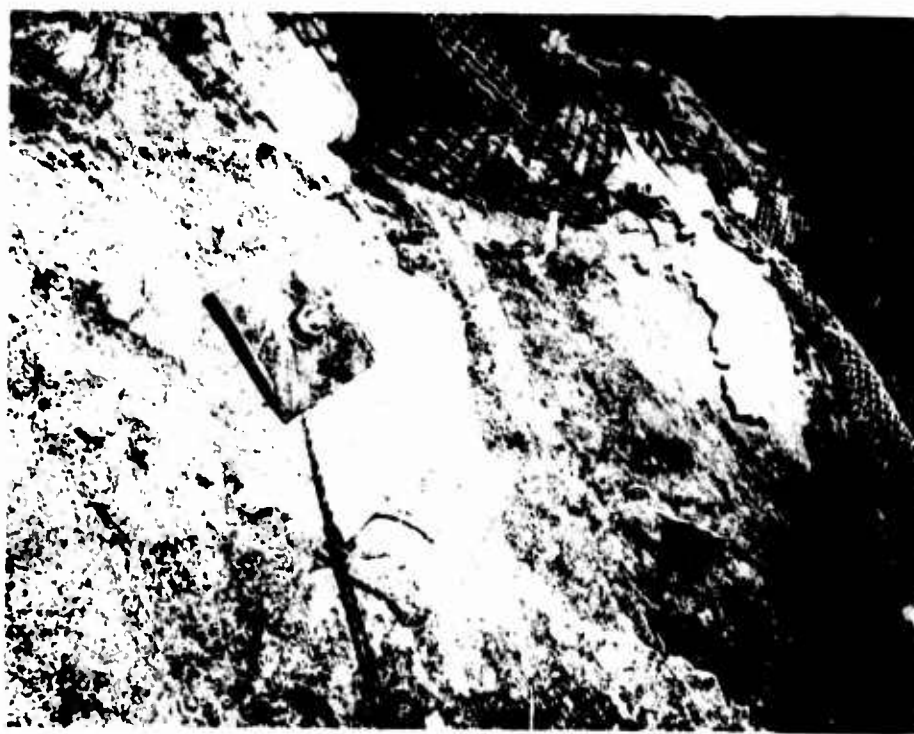
Fig. 19. Plane face of Cavity III

the dome.) Many of the irregularities of the cavity surface were caused by the major high angle fault system and the low angle joint system which were first encountered in the main drift. Weathering and alteration were observed on many of the faults and some of the joints which intersected the cavity. Limonite stains, sericite, and pyrite were present in addition to the products of shear and crushing (mylonites and gouge), which formed along fault planes.
